Manhole Inspection Summary

Manhole # S39G__002MH

Insp Date: **3/27/08 9:30 AM**

Location Address: **1029 watson**

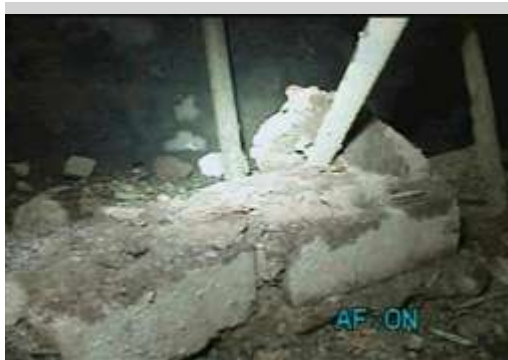
Defect 3

Condition: ☐ Sound ☐ Cracked ☐ Root Intrusion ☐ Deteriorated ☐ Leaks ☒ **Debris**

channel debris

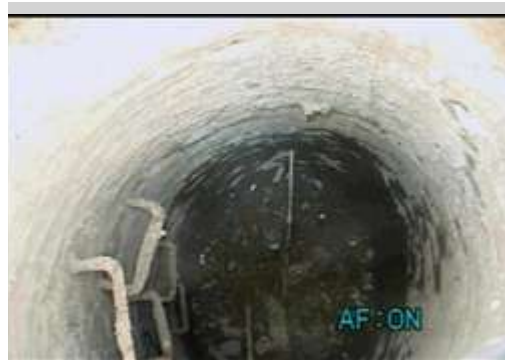
Defect 2

Infiltration: ☐ None ☐ Joint ☐ Cracks ☐ Mortar ☐ Roots ☒ **Wall**

Count: **5** Missing: **0** ☒ **Corroded**

corroded steps, barrel wall infiltration

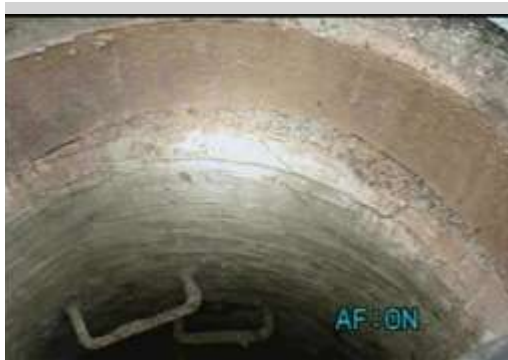
Defect 1

Offset: **2** (in.)

frame adjustment & offset

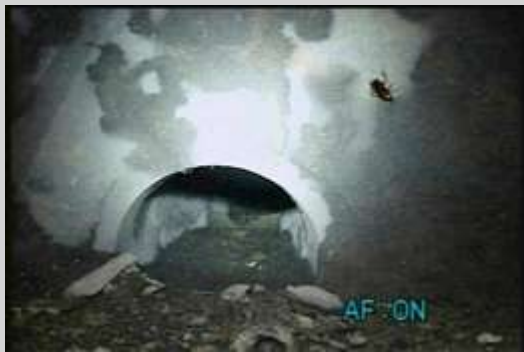
12 O'Clock Outflow

8 in. Circular Gravity Sewer
Pipe Out @ 12 O'Clock

Deposits: ☐ None ☐ Mud ☐ Sludge ☒ **Debris** ☐ Grease

Silt Depth: **3** (in.) Deposits Extent: **Light**
